## St Martin's Church Centre renovation project: A Net Zero Carbon Demonstrator Project in Pictures

# St Martin's Church Centre renovation project: A Net Zero Carbon Demonstrator Project in Pictures

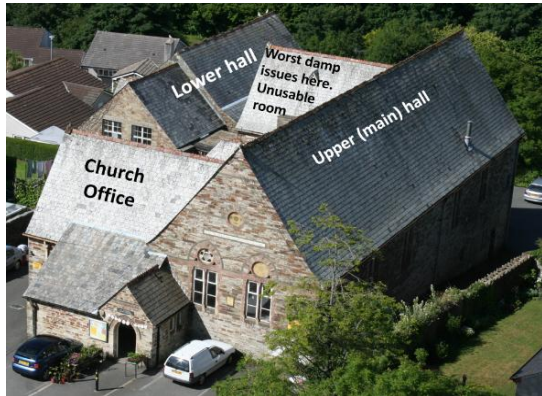
The layout of the Church Centre

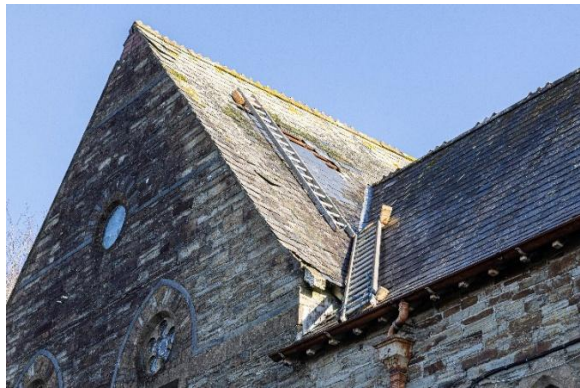
Emergency repair work to roof following Storm Henk.

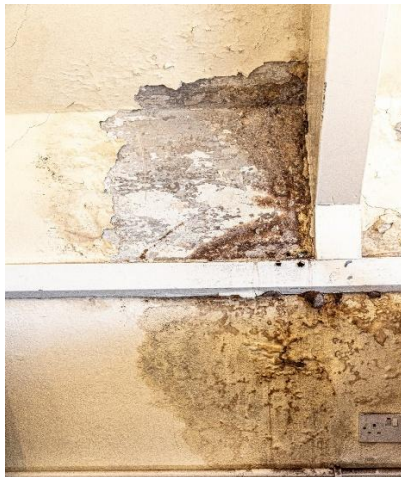
Damp and fungi in the upper room

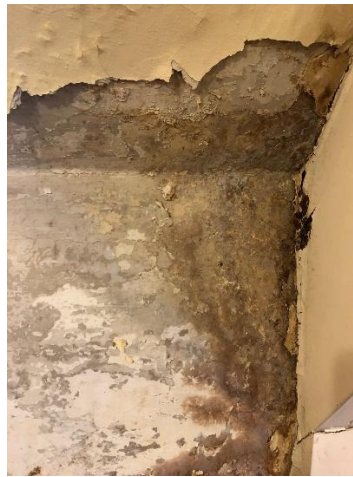
Damp outside the upper room

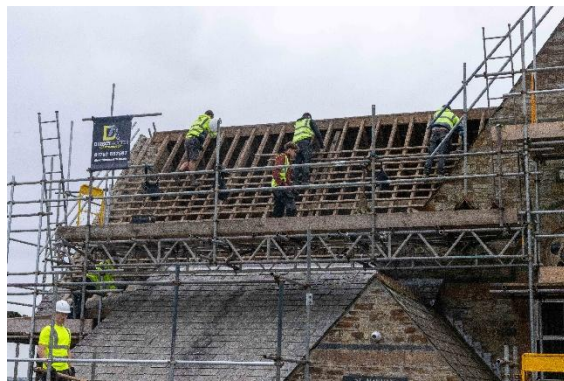
14 Oct 25 – The roofers arrive and start stripping the front east-facing roof

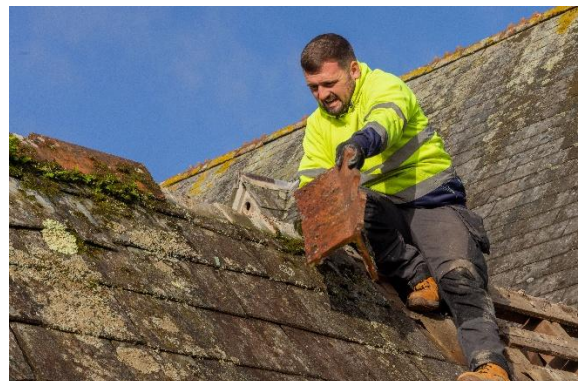
20 Oct 25 - Stripping the ABC store (middle part of the E shape)

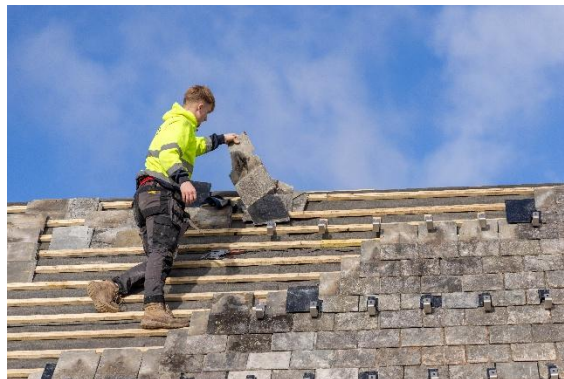
20 Nov 25 – reroofing the south roof, around the solar panel hooks

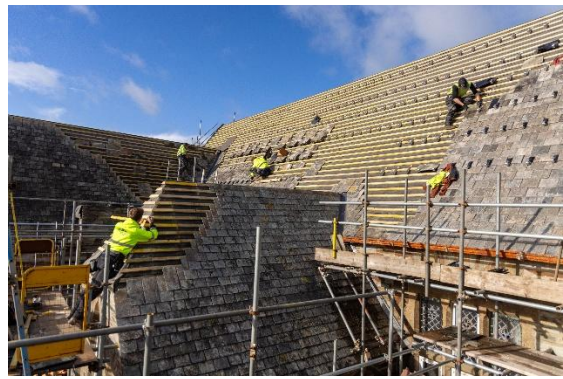
20 Nov 25 – reroofing the south roof around the solar panel hooks

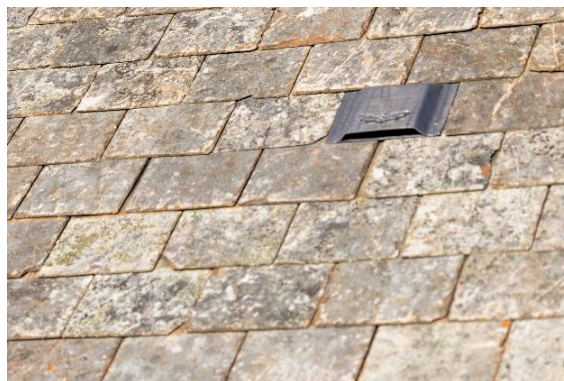
20 Nov 25 – Bat entrances built into the roof.

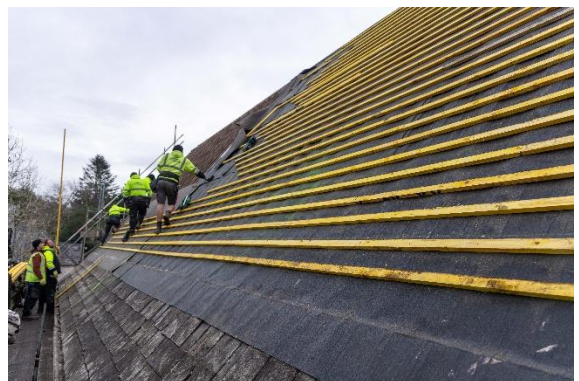
26 Nov 25 – Stripping slates, insulating, then felting and battening the north roof.

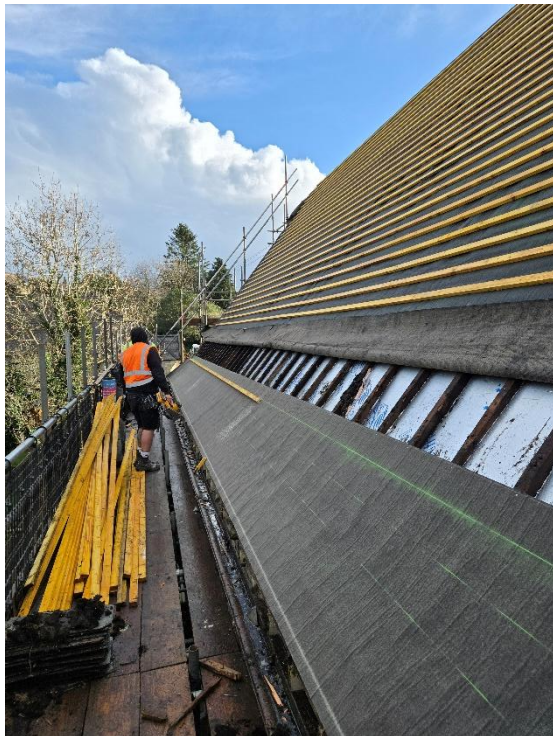
2 Dec 25 – Felt and battening after insulation added in-between the roof rafters.

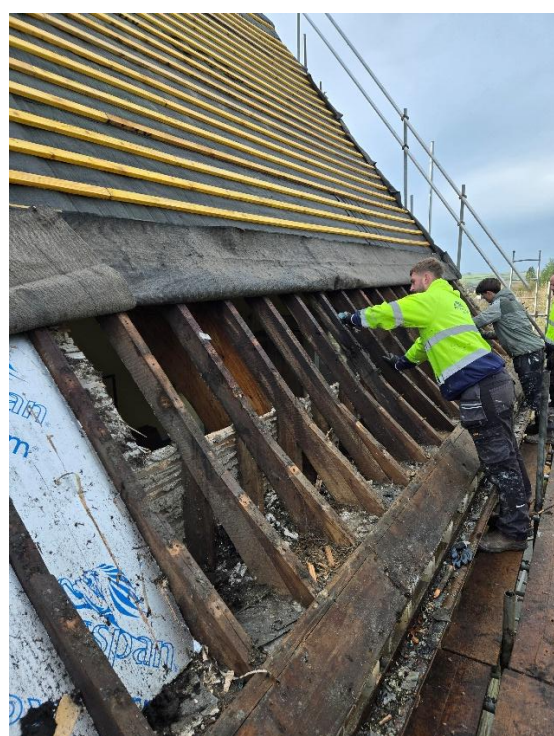
2 Dec 25 – Preparations before adding the final insulation to the north roof.

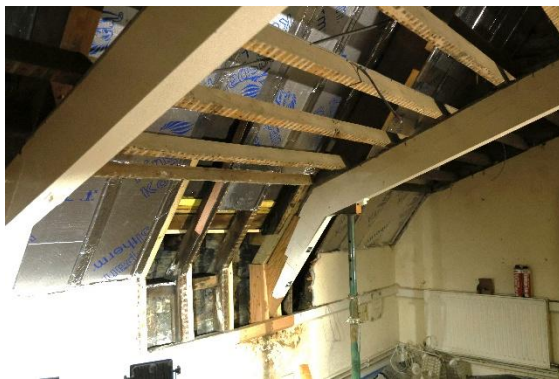
14 Nov 25 – Sister repair made to rotten wood in upstairs "Upper Room". Note insulation between the rafters and behind new plasterboard ceiling.

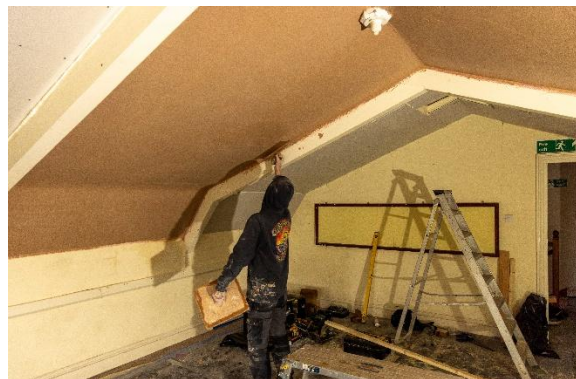
26 Nov 25 –plastering over new insulated ceiling in upstairs room, the "Upper Room".

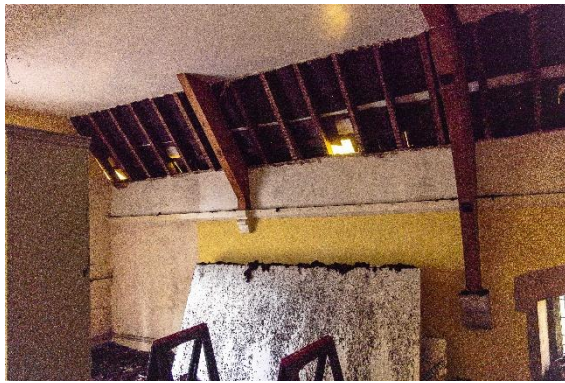
26 Nov 25 – Removing old plasterboard ceiling in upstairs room "Siloam"

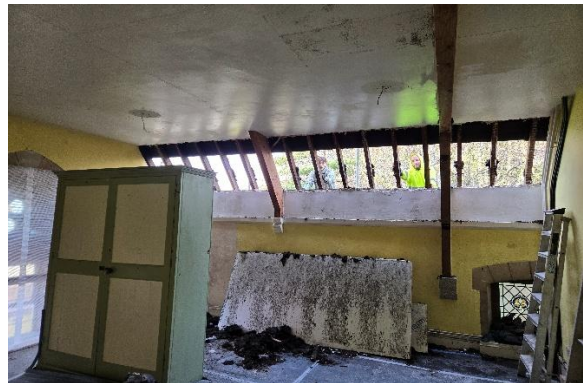
2 Dec 2025 – Roof stripped outside "Siloam", ready for the insulation.

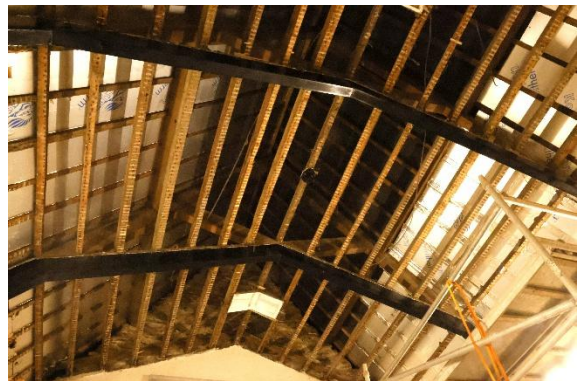
12 Jan 26 – Old plasterboard ceilings removed

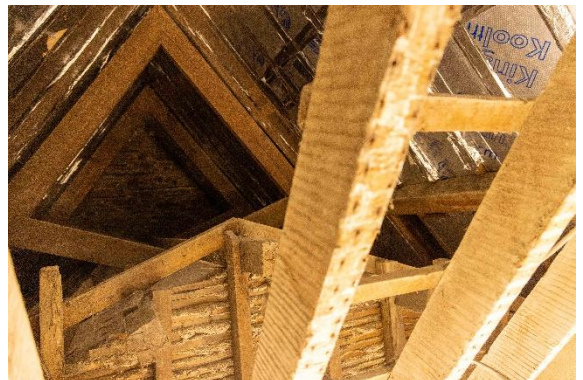
4 Feb 26 – Insulation between the roof rafters

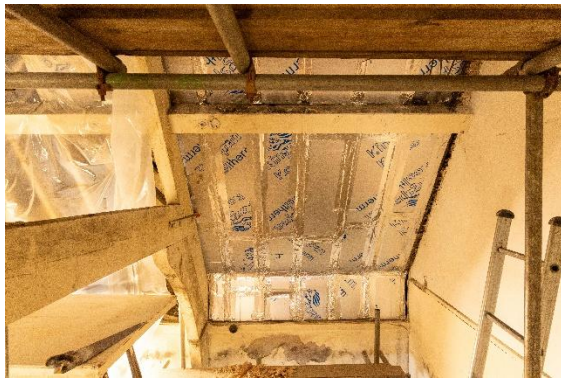
4 Feb 26 – New insulated plasterboard ceiling in the inner lobby area

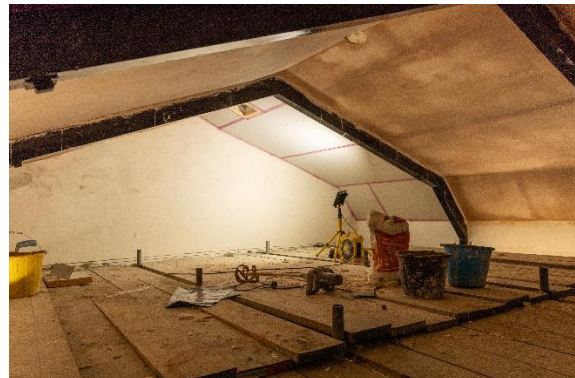
4 Feb 26 – New insulated plasterboard ceiling being plastered in the "Upper Room"

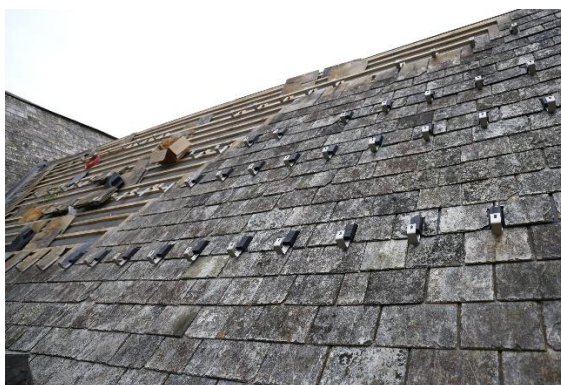
26 Nov 25 – Solar panel hooks in place for grid

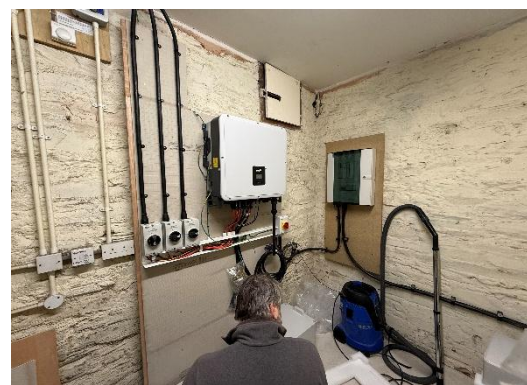
27 Jan 26 – Inverter and wiring in place and batteries being installed

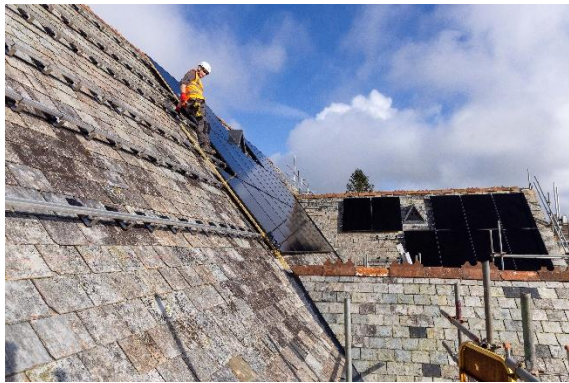
6 Feb 26 – Solar panels being installed

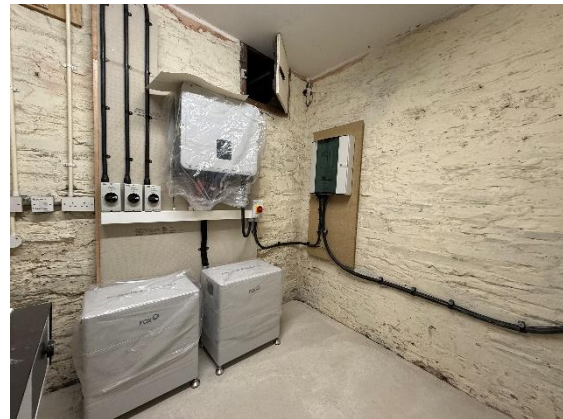
The finished system – 40 kWh batteries resting on new concrete base in the plant room.

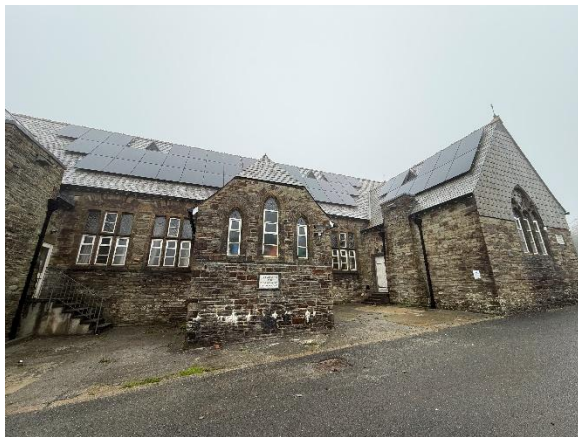
20 Apr 26 – Solar panels on the south and west roof slopes

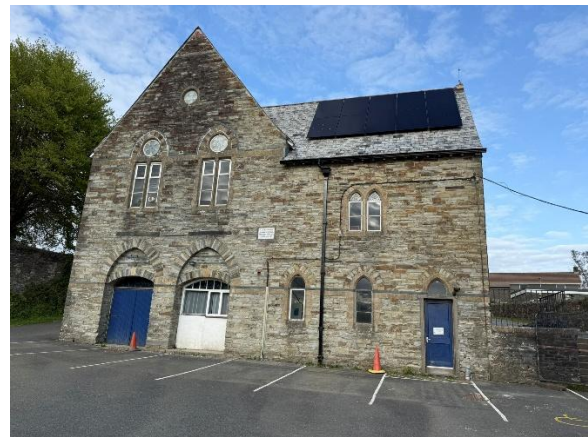
20 Apr 26 – Solar panels on the rear west-facing roof slope.

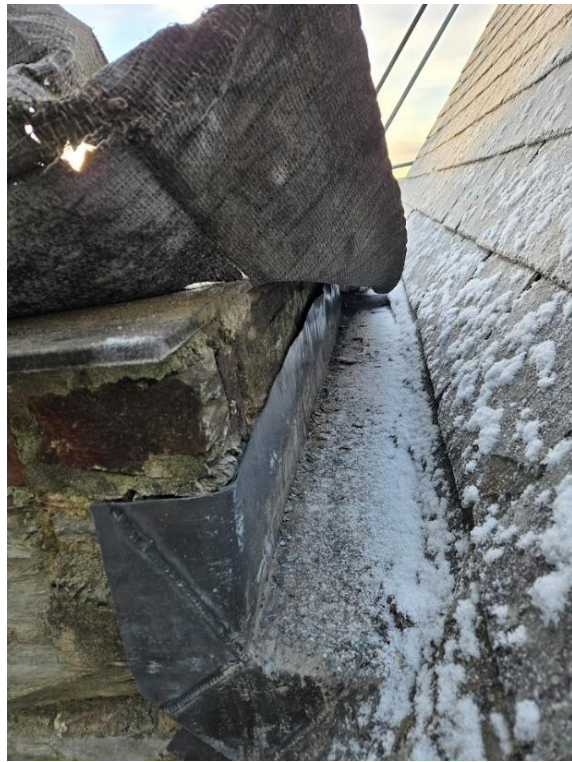
6 Jan 26 – the starting position. Gaps behind the lead and slates topping the chimneys were loose.

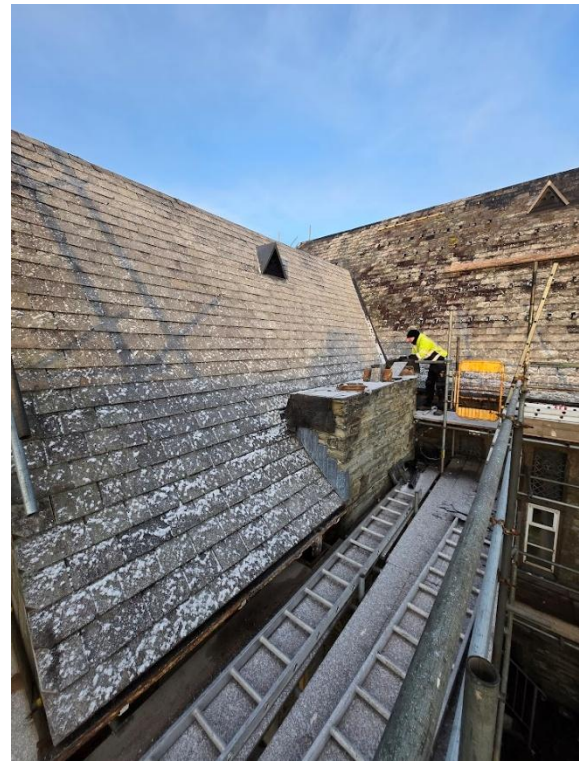
6 Jan 26 – the second chimney was in the worst condition, leading to major damp issues in the Upper Room (first floor) and Jericho, the room below.

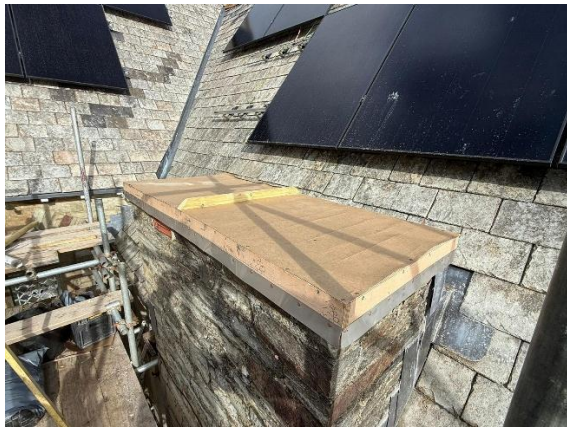
12 Feb 26 – remove the old capping and build new frame.

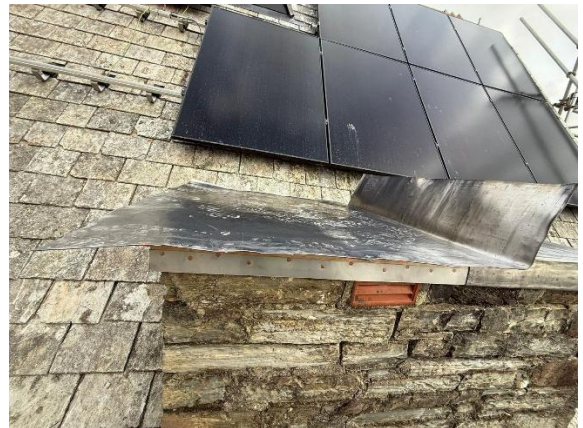
12 Feb 26 – start covering the new frame with lead.

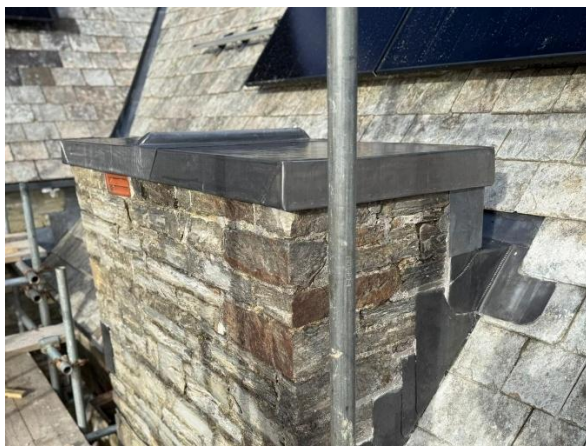
12 Feb 26 – the new lead capping is finished.

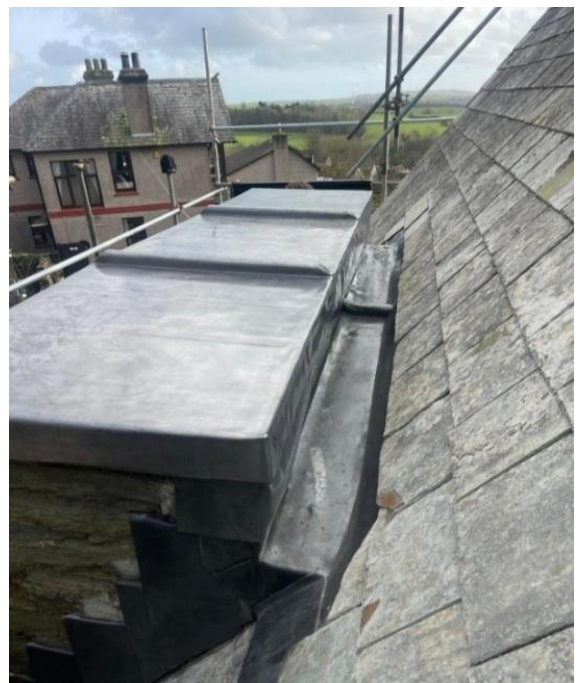
12 Feb 26 – the second, larger chimney is also finished.

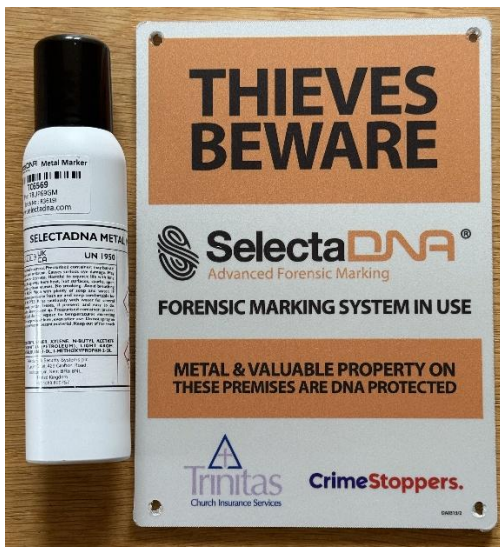
12 Feb 26 All new lead marked with SelectaDNA to protect against theft.

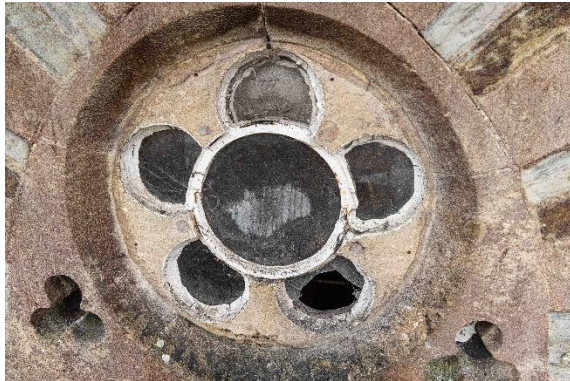
19 Feb 26 – the starting point – broken glass.

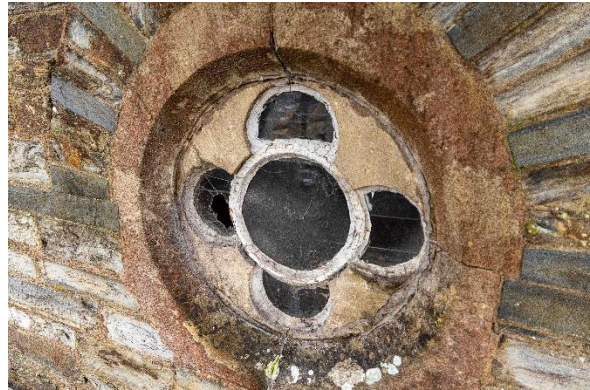
19 Feb 26 – the starting point – broken glass.

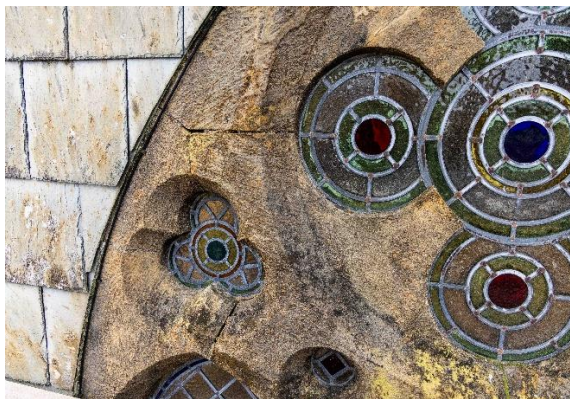
19 Feb 26 – the starting point – stonework around oriel windows in need of repointing

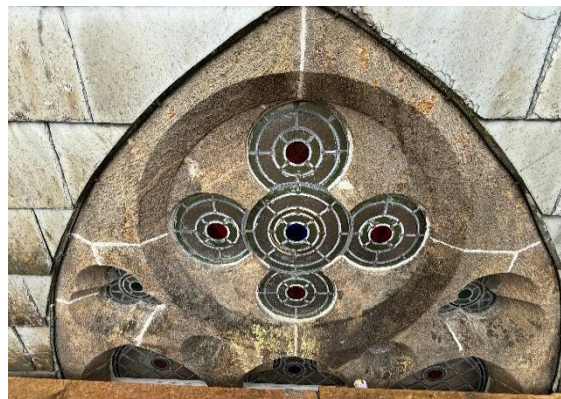
27 Mar 26 – repointing completed around the oriel windows

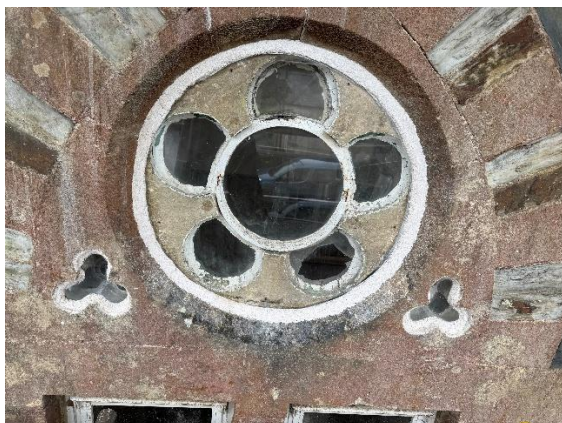
27 Mar 26 – repointing completed and external secondary glazing fitted.

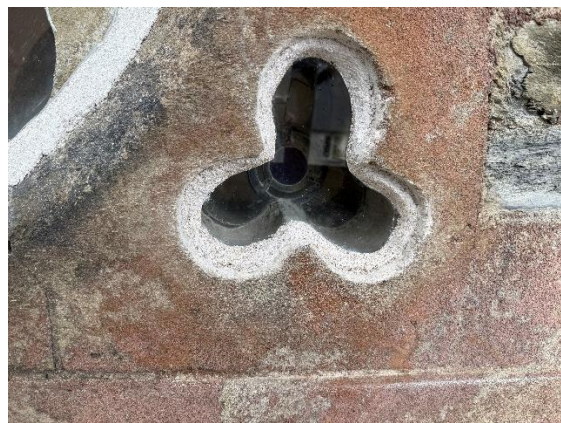
27 Mar 26 – repointing completed and external secondary glazing fitted.

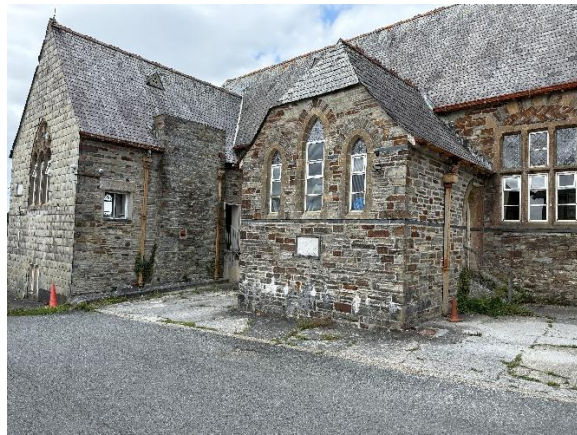
21 Aug 25 – the starting point, with all the cracked and broken concrete.

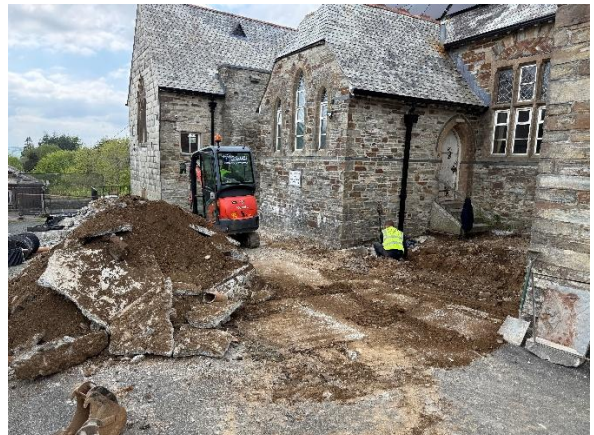
28 Apr 26 – digging up the old concrete.

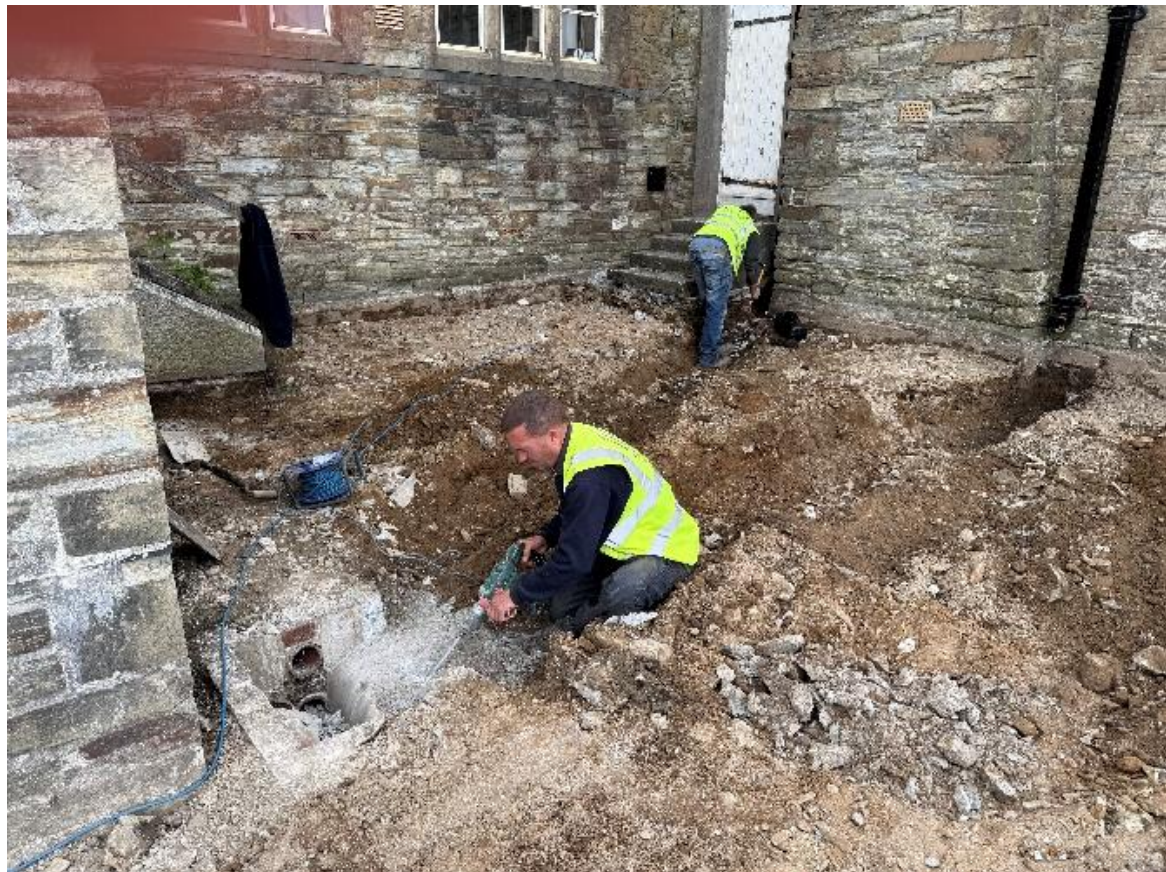
28 Apr 26 – preparing the new channels for the drains.

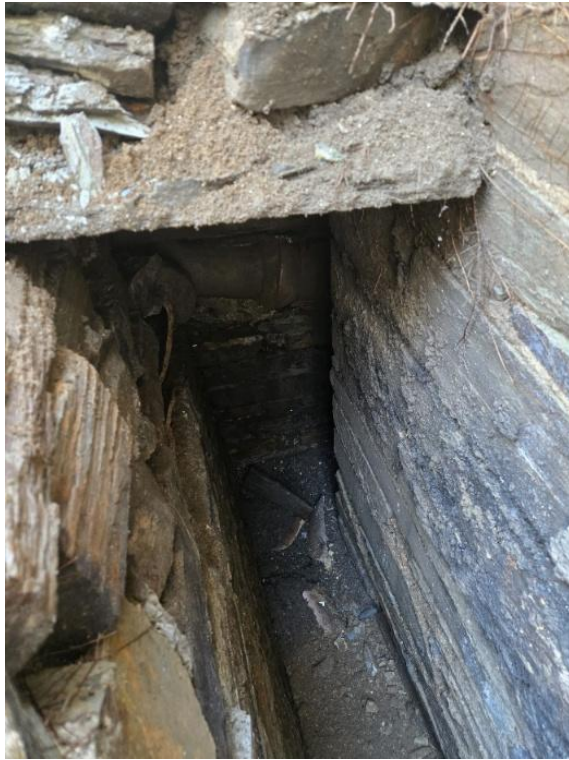
5 May 26 – 5-foot deep culvert discovered.

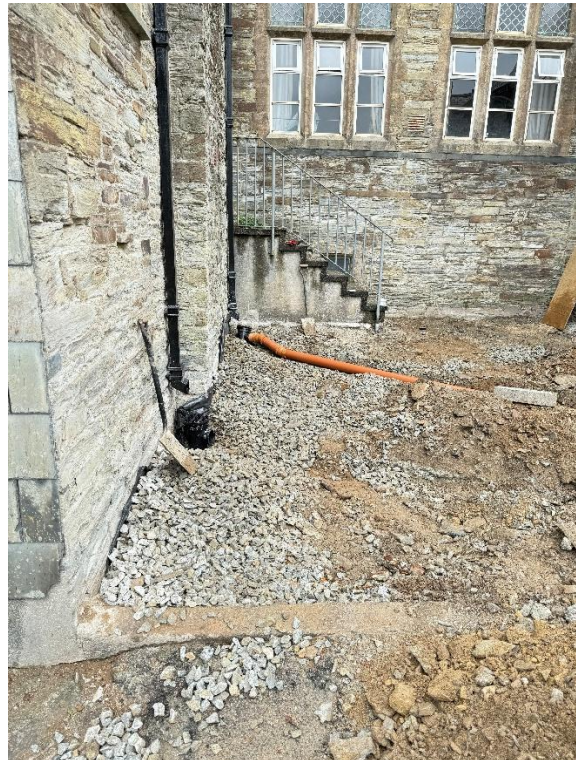
18 May 26 – Terram membrane added and French drain created in culvert.

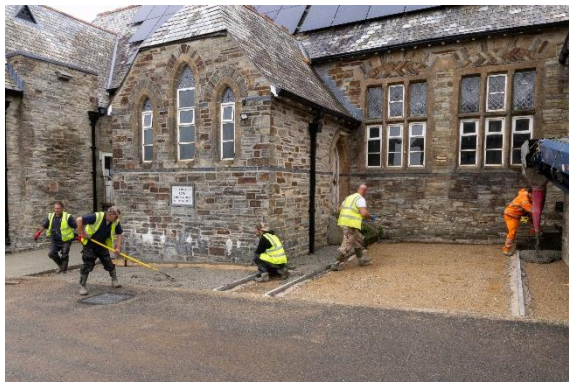
18 Jun 26 – Re-concreting

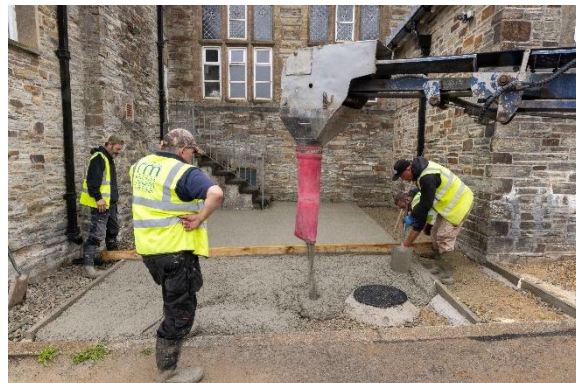
18 Jun 26 – Re-concreting

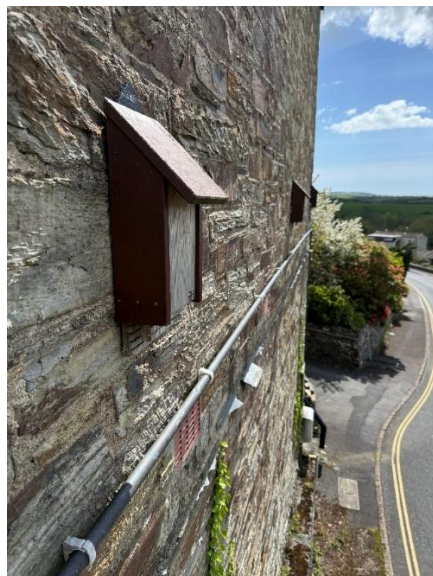
21 Jun 25 – four bat boxes installed as mitigation.

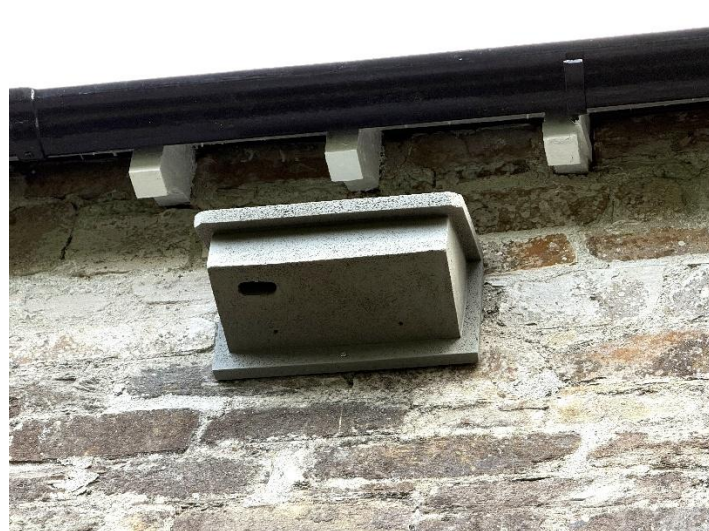
27 Mar 26 – four swift nesting boxes installed around the building.
